Town of Charlestown

Stormwater Vulnerability & Floodplain Management Assessment

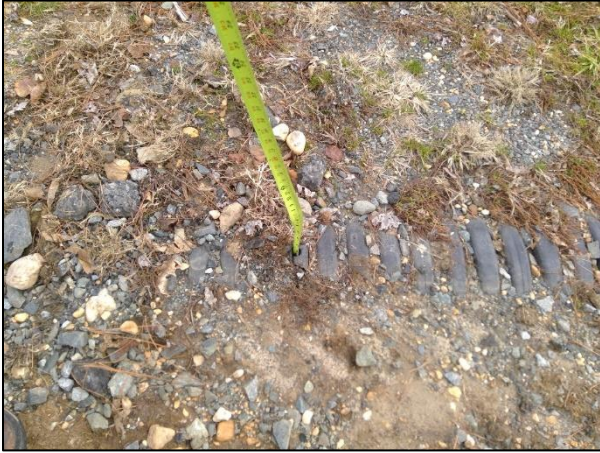
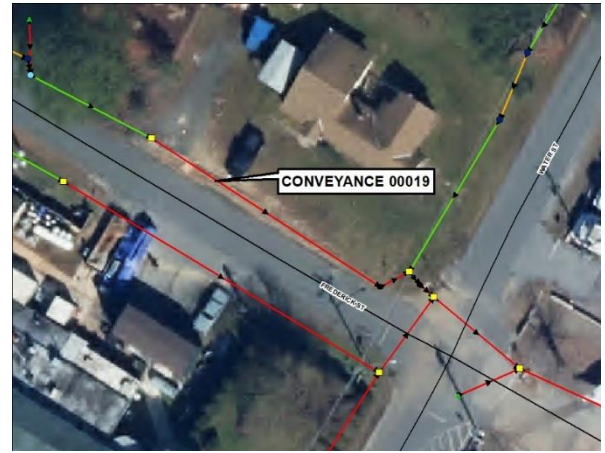
DATE: 01-07-19
CONVEYANCE ID: 00019
DEFECT DESCRIPTION: Hole in the top of an exposed pipe.
PRIORITY: High

ADDRESS: 613 Water Street
PROPERTIES: 15" HDPE
LOCATION:

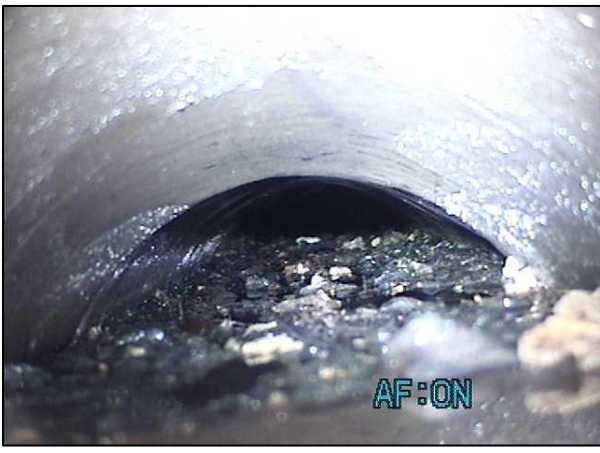
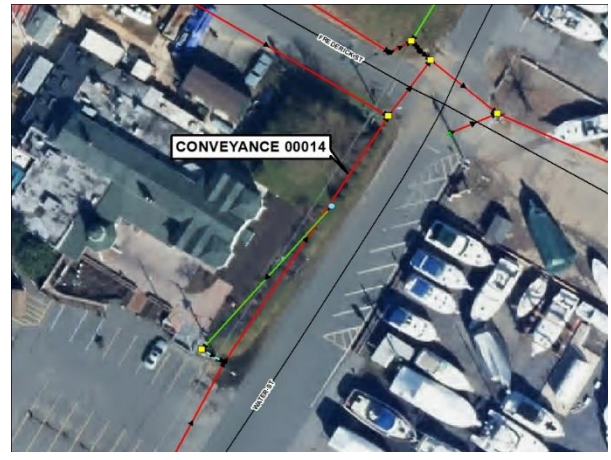
DATE: 01-07-19
CONVEYANCE ID: 00014
DEFECT DESCRIPTION: Pipe is 80% full of debris.
PRIORITY: High

ADDRESS: 523 Water Street
PROPERTIES: 15" RCP
LOCATION:

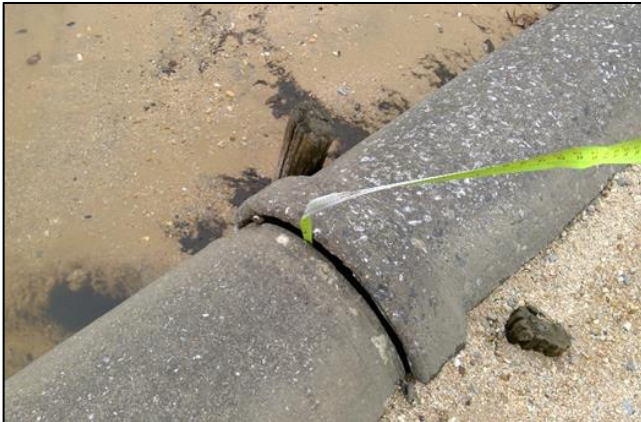
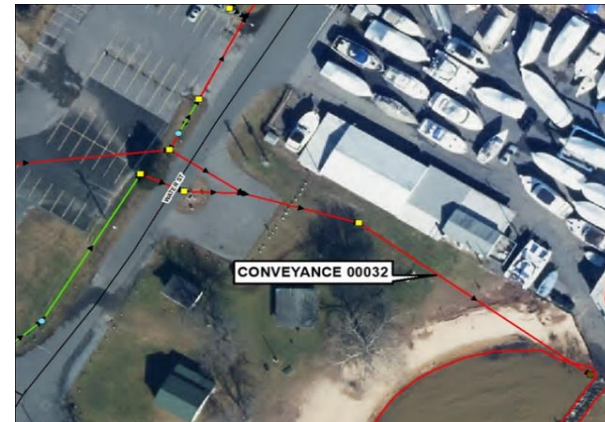
DATE: 01-07-19
CONVEYANCE ID: 00032
DEFECT DESCRIPTION: Exposed pipe with joint separation.
PRIORITY: High

ADDRESS: 524 Water Street
PROPERTIES: 21" RCP
LOCATION:

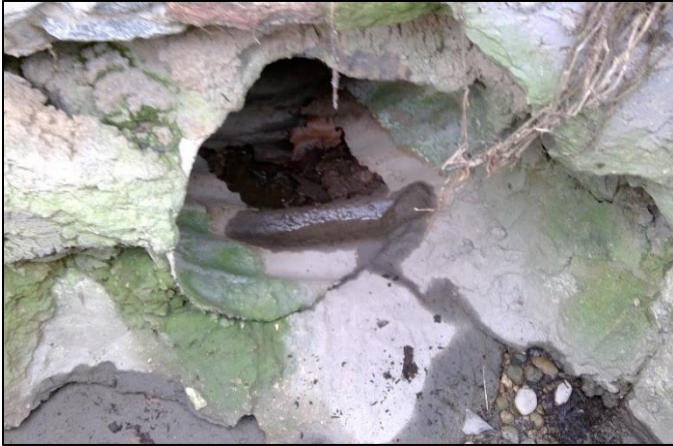
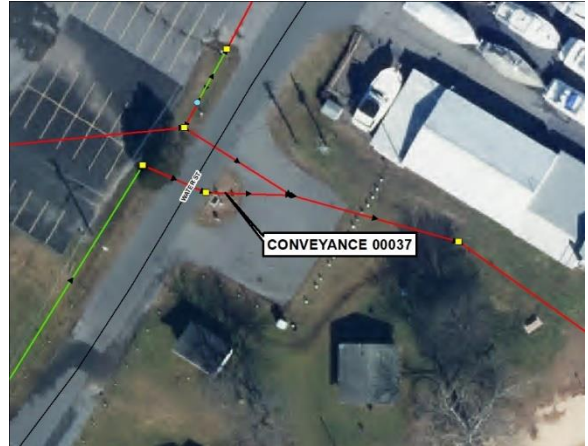
DATE: 01-07-19
CONVEYANCE ID: 00037
DEFECT DESCRIPTION: CMP with hole in the bottom.
PRIORITY: High

ADDRESS: 524 Water Street
PROPERTIES: 15" CMP

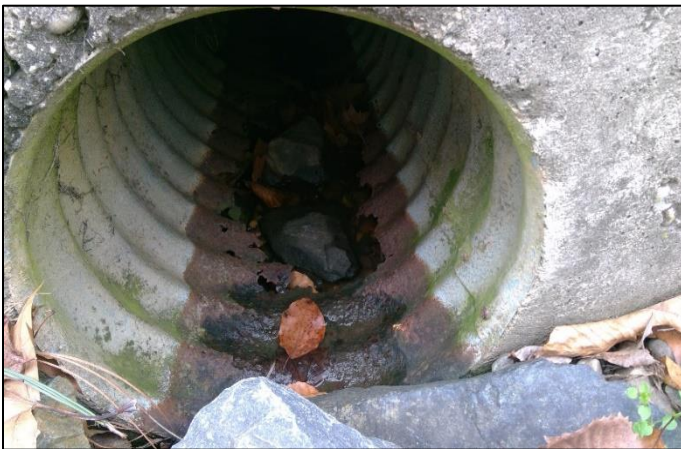
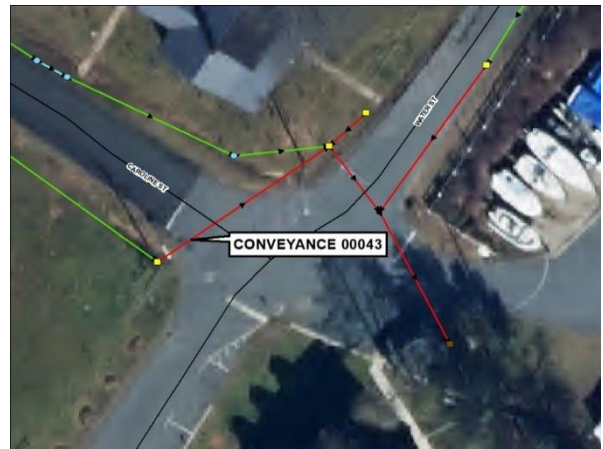
DATE: 01-07-19
CONVEYANCE ID: 00043
DEFECT DESCRIPTION: CMP with hole in the bottom.
PRIORITY: High

ADDRESS: 724 Water Street
PROPERTIES: 15" CMP

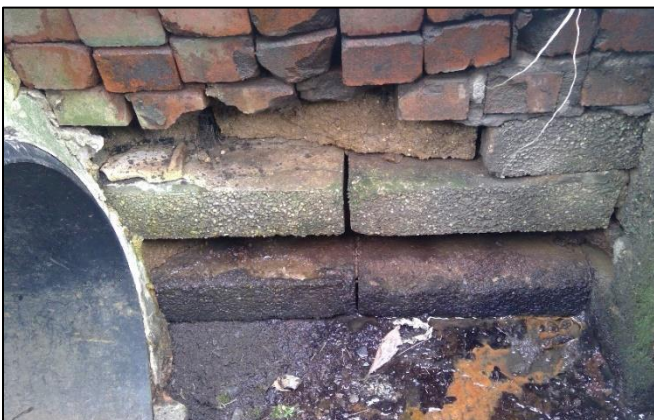
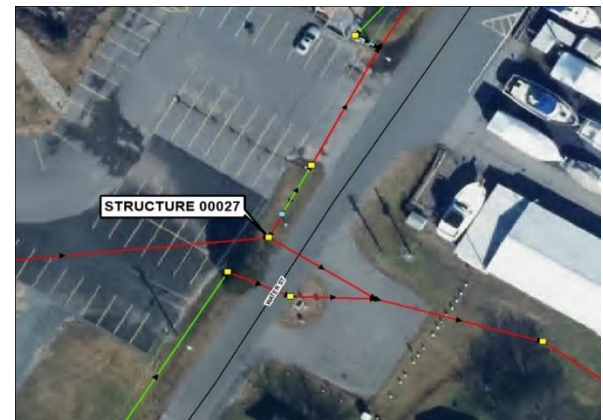
DATE: 01-07-19
STRUCTURE ID: 00027
DEFECT DESCRIPTION: Missing material in the side of the wall.
PRIORITY: Low

ADDRESS: 523 Water Street
PROPERTIES: N/A

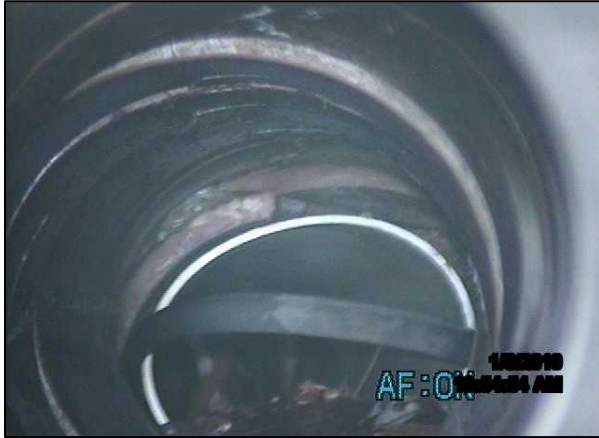
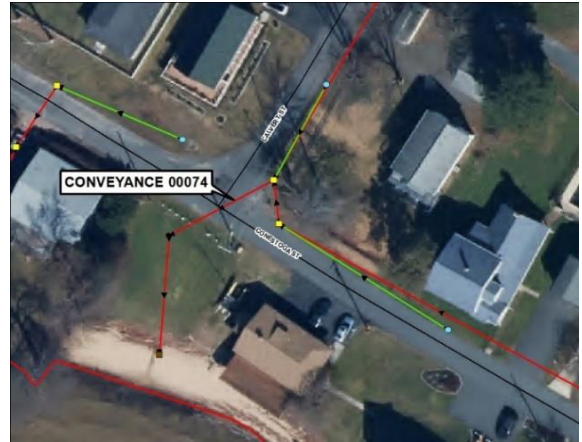
DATE: 01-08-19
CONVEYANCE ID: 00074
DEFECT DESCRIPTION: Joint separation.
PRIORITY: Low

ADDRESS: 205 Conestoga Street
PROPERTIES: 10" PVC

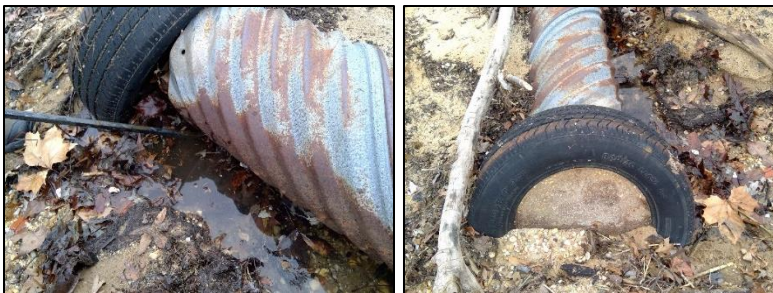
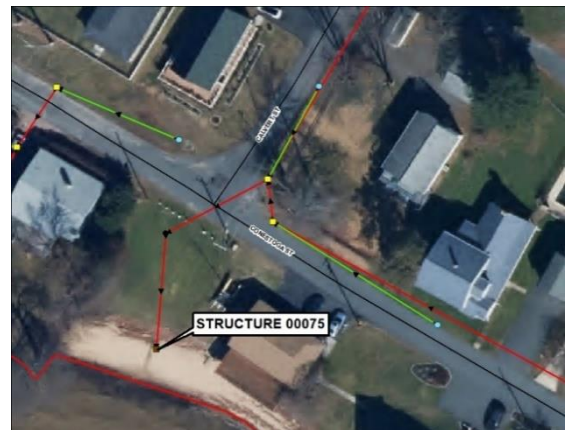
DATE: 01-08-19
STRUCTURE: 00075
PRIORITY: High
DEFECT DESCRIPTION: Bottom of the pipe is missing.
DEFECT DESCRIPTION: A tire filled with concrete was placed on the end of the outfall blocking water from leaving the system.

ADDRESS: 205 Conestoga Street
PROPERTIES: N/A
LOCATION:

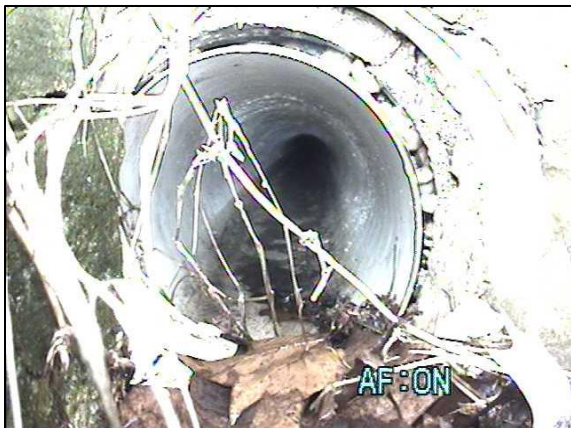
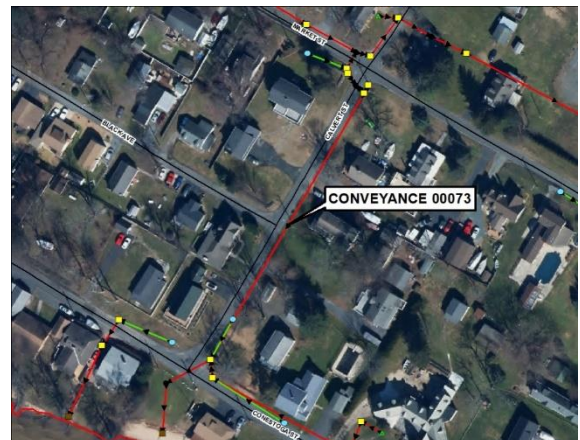
DATE: 01-09-19
CONVEYANCE ID: 00073
DEFECT DESCRIPTION: Joint separation in the upstream end of the conveyance near the seal.
PRIORITY: Low

ADDRESS: 424 Calvert Street
PROPERTIES: 8" PVC
LOCATION:

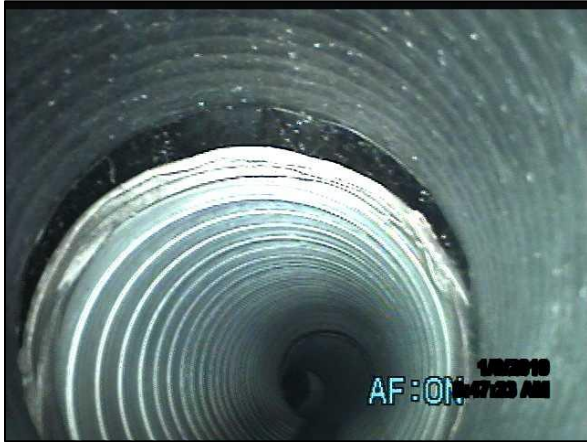
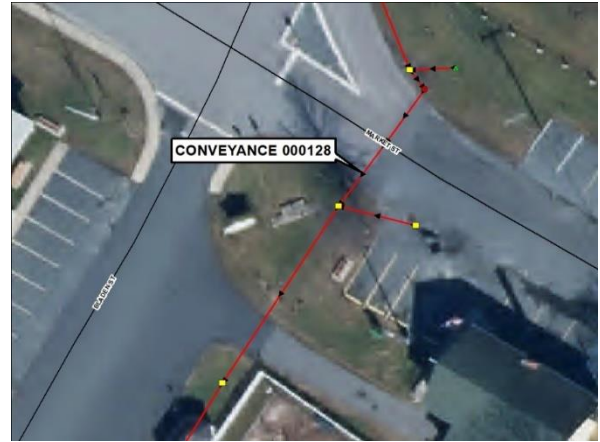
DATE: 01-09-19
CONVEYANCE ID: 00128
DEFECT DESCRIPTION: Joint separation where the pipe material changes.
PRIORITY: Low

ADDRESS: 241 Market Street
PROPERTIES: 18" HDPE
LOCATION:

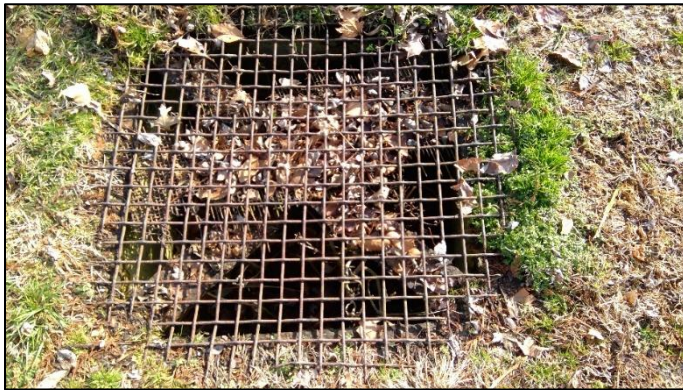
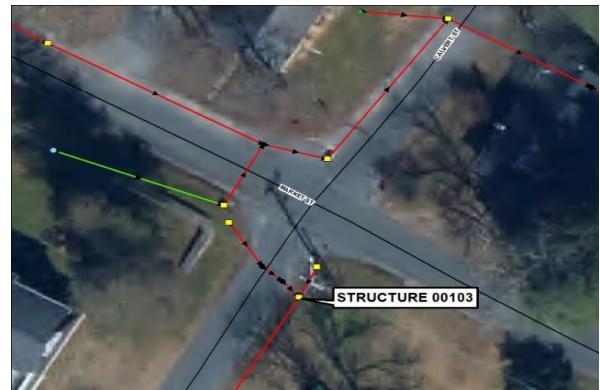
DATE: 01-09-19
STRUCTURE ID: 00103
DEFECT DESCRIPTION: Cast iron grate placed on inlet does not support weight, no frame.
PRIORITY: High

ADDRESS: 424 Calvert Street
PROPERTIES: N/A
LOCATION:

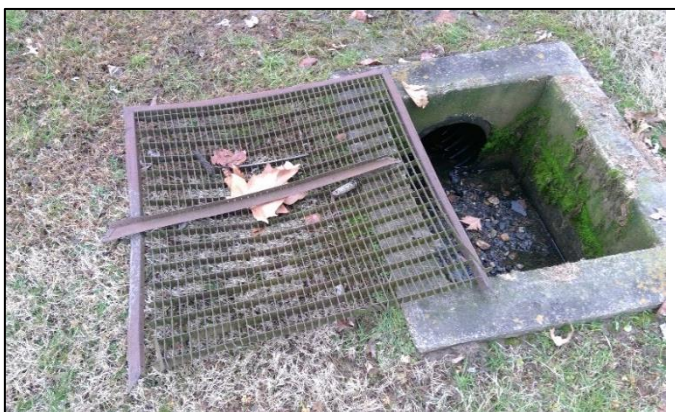
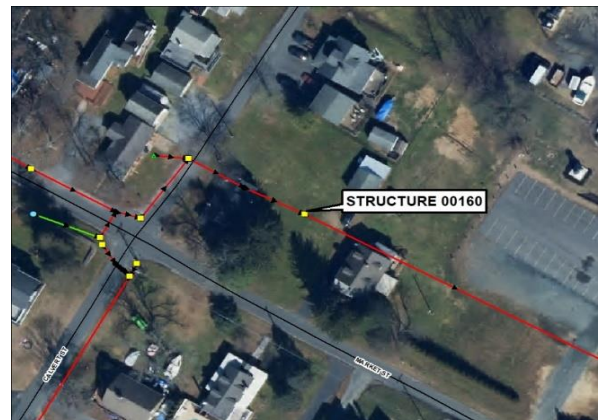
DATE: 01-09-19
STRUCTURE ID: 00160
DEFECT DESCRIPTION: Grate bent in, side of grate broken off, and no frame.
PRIORITY: High

ADDRESS: 132 Market Street
PROPERTIES: N/A
LOCATION:

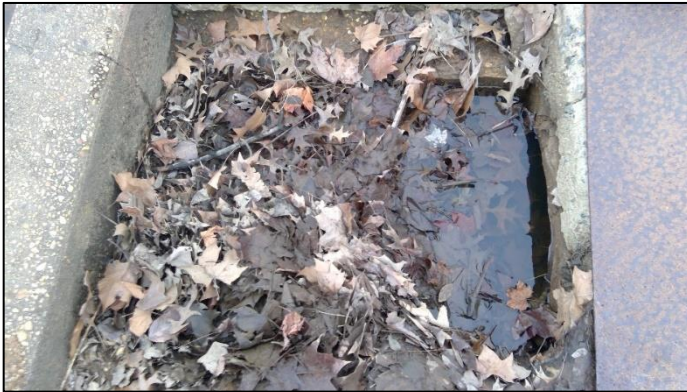
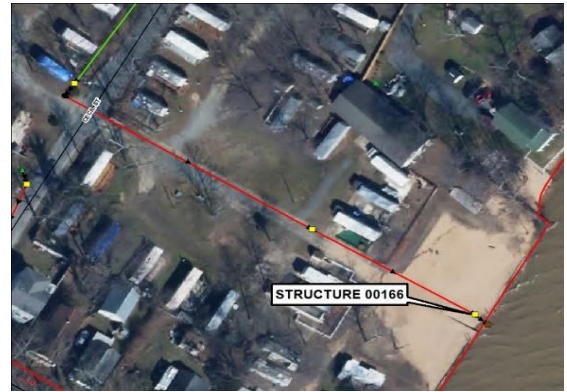
DATE: 01-09-19 **ADDRESS:** Beach Road
STRUCTURE ID: 00166 **PROPERTIES:** N/A
DEFECT DESCRIPTION: Filled with leaves/water, no grate or frame (just sheet metal resting on top).
PRIORITY: High **LOCATION:**

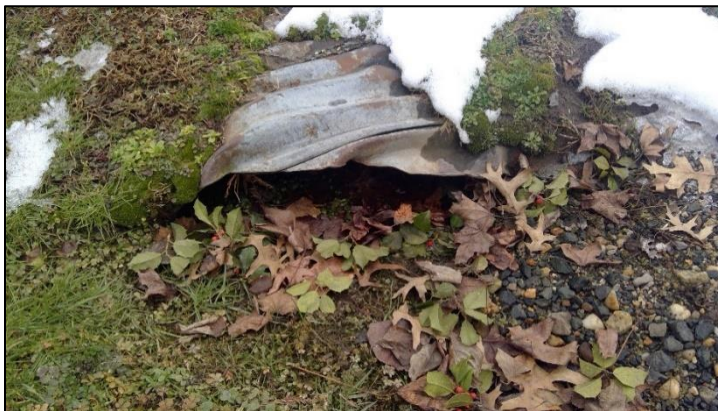
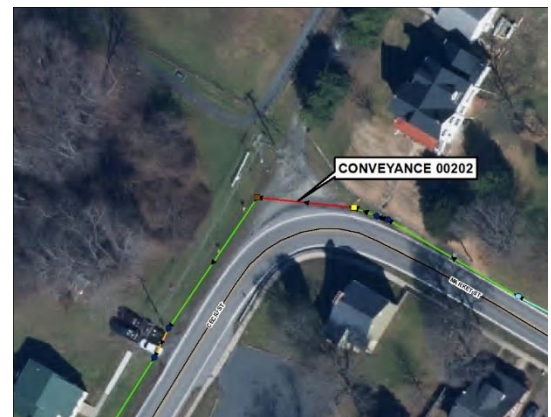
DATE: 01-16-19 **ADDRESS:** Cecil Street (front of 344 Market Street)
CONVEYANCE ID: 00202 **PROPERTIES:** 18" CMP
DEFECT DESCRIPTION: Pipe is 70% full of debris.
PRIORITY: High **LOCATION:**

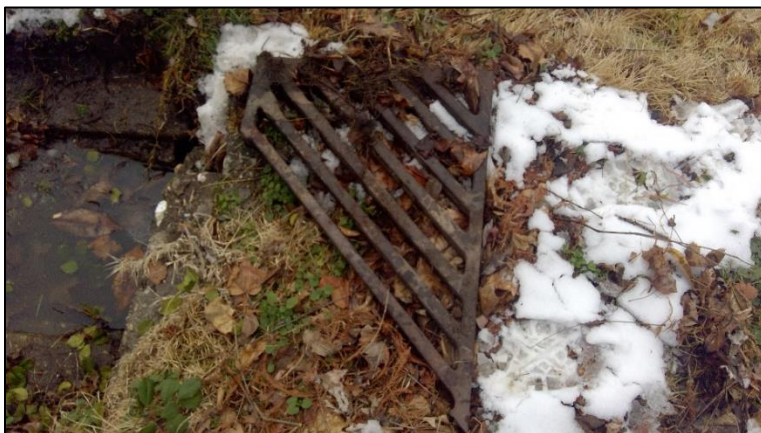
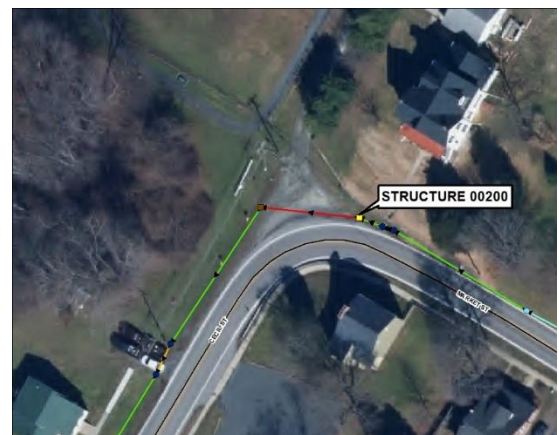
DATE: 01-16-19 **ADDRESS:** Cecil Street (front of 344 Market Street)
STRUCTURE ID: 00200 **PROPERTIES:** N/A
DEFECT DESCRIPTION: Grate of the structure is broken.
PRIORITY: Low **LOCATION:**

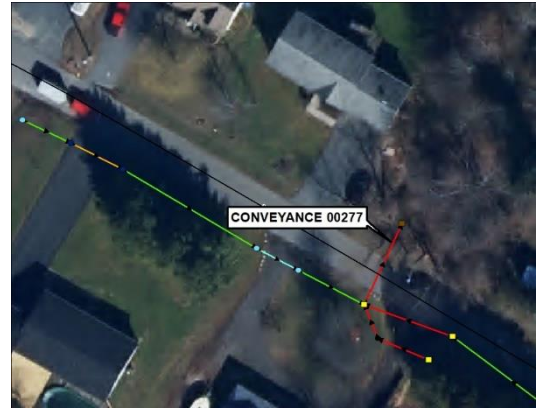
DATE: 01-22-19 & 01-23-19
CONVEYANCE ID: 00277
PRIORITY: High

DEFECT DESCRIPTION:
Bottom of the pipe is corroded and downstream end is misshapen.

DEFECT DESCRIPTION:
Joint separation in the upstream end of the pipe.

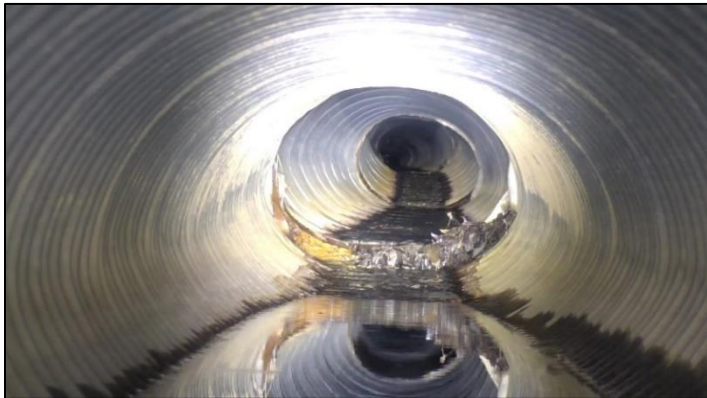
DATE: 01-23-19
CONVEYANCE ID: 00297
DEFECT DESCRIPTION: Joint separation in the bottom of the pipe.
PRIORITY: Low

ADDRESS: Chesapeake Road
PROPERTIES: 17"x13" Arch CMP
LOCATION:

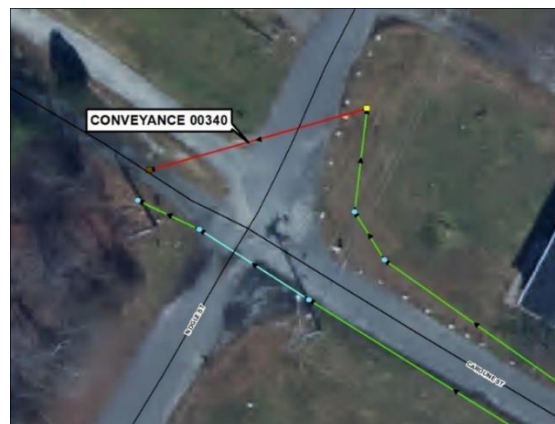
DATE: 01-25-19
CONVEYANCE ID: 00340
DEFECT DESCRIPTION: Exposed pipe with joint separation that is also 70% filled with debris.
PRIORITY: High

ADDRESS: 708 North Ogle Street
PROPERTIES: 12" CMP
LOCATION:

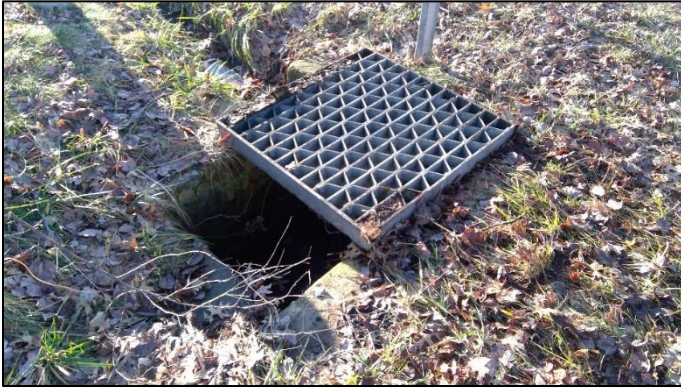
DATE: 01-25-19 **ADDRESS:** Frederick Street (side of 601 N Ogle Street)
STRUCTURE ID: 00336 **PROPERTIES:** N/A
DEFECT DESCRIPTION: Grate does not sit properly in the frame.
PRIORITY: High **LOCATION:**

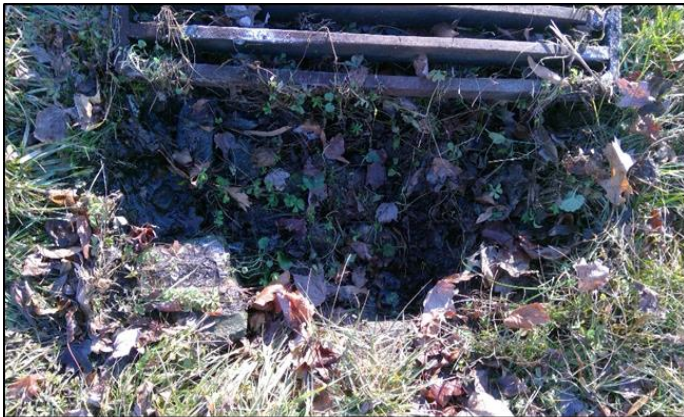
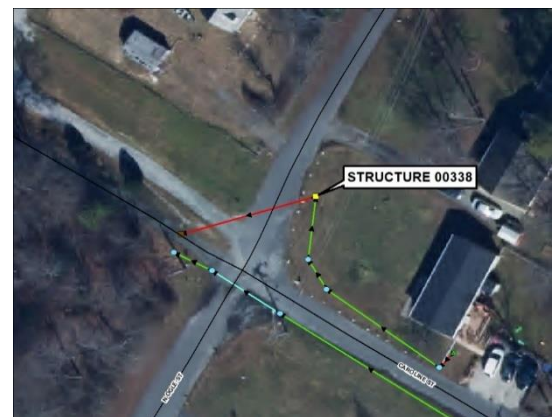
DATE: 01-25-19 **ADDRESS:** 708 North Ogle Street
STRUCTURE ID: 00338 **PROPERTIES:** N/A
DEFECT DESCRIPTION: Filled 90% with debris
PRIORITY: High **LOCATION:**

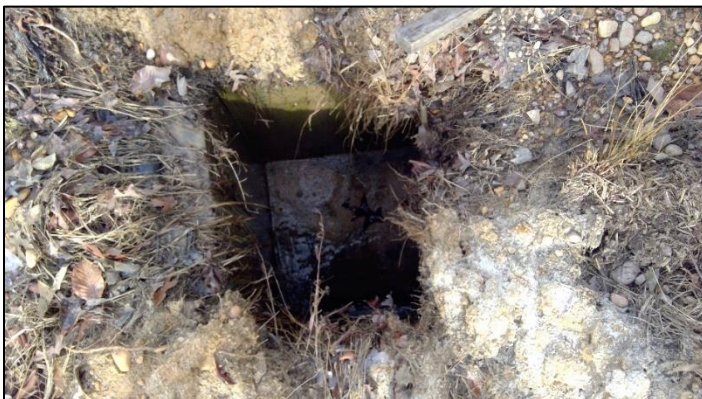
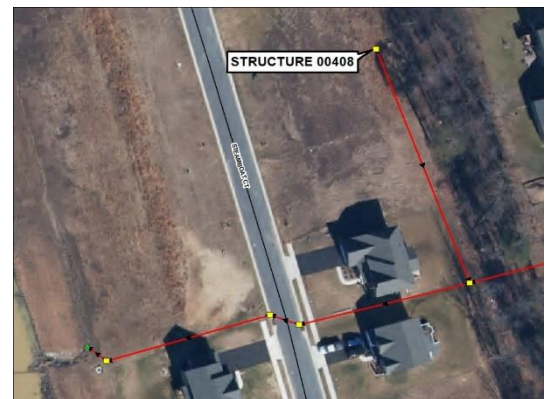
DATE: 01-28-19 **ADDRESS:** Behind 137 Steamboat Court
STRUCTURE ID: 00408 **PROPERTIES:** N/A
DEFECT DESCRIPTION: Missing grate in construction zone.
PRIORITY: High **LOCATION:**

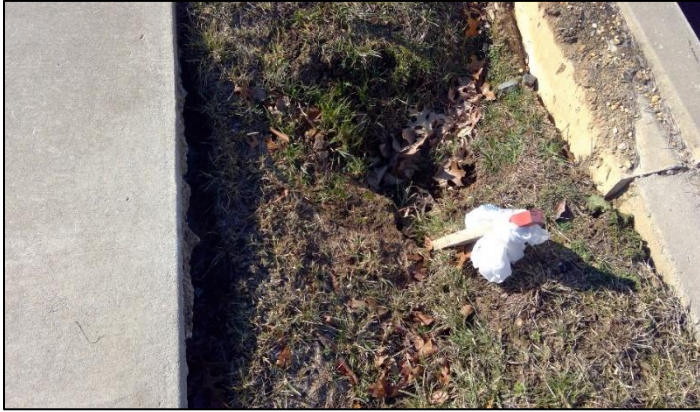
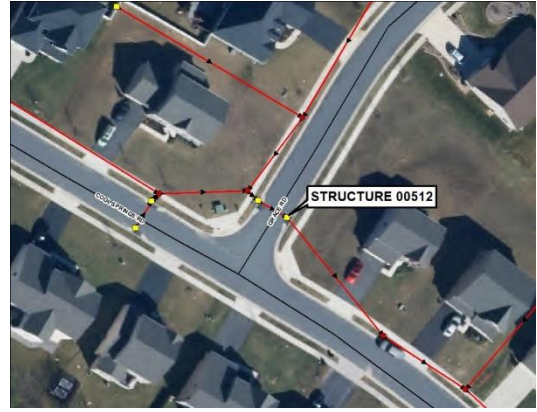
DATE: 01-30-19 **ADDRESS:** Grace Road (side of 136 Cool Springs Drive)
STRUCTURE ID: 00512 **PROPERTIES:** N/A
DEFECT DESCRIPTION: Closed drainage sinkhole forming directly behind structure.
PRIORITY: Low **LOCATION:**

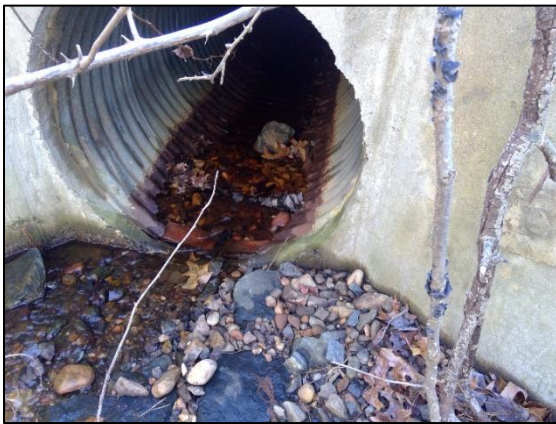
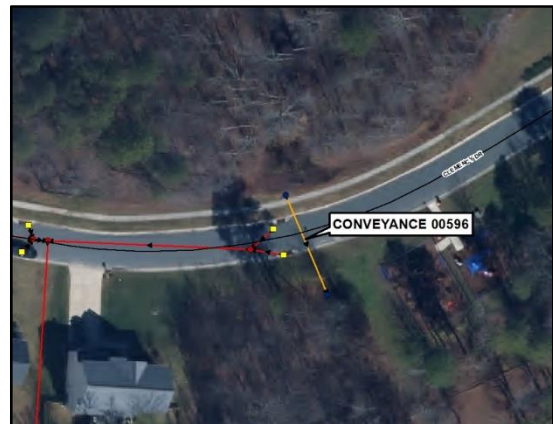
DATE: 02-04-19 **ADDRESS:** Clemency Drive
CONVEYANCE ID: 00596 **PROPERTIES:** 36" CMP
DEFECT DESCRIPTION: The bottom of the pipe is corroded.
PRIORITY: High **LOCATION:**

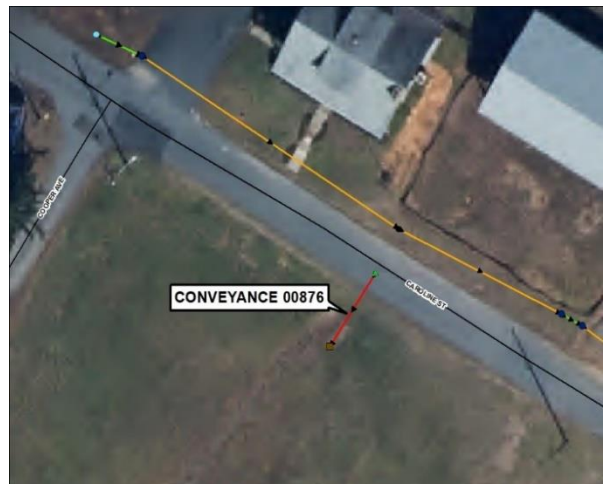
DATE: 03-26-19 **ADDRESS:** 216 Caroline Street (across from)
CONVEYANCE ID: 00876 **PROPERTIES:** 12" CMP
PRIORITY: High **LOCATION:**

DEFECT DESCRIPTION:
 Hole in the top of the pipe.

DEFECT DESCRIPTION:
 A pipe segment is detached.

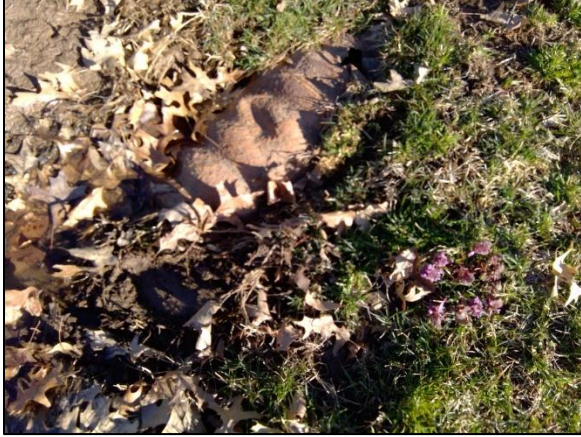
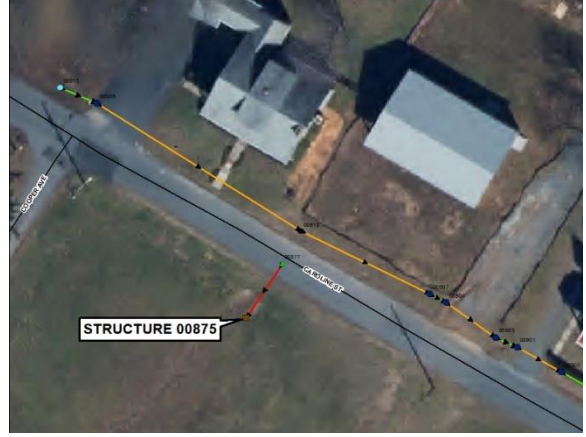
DATE: 03-26-19
STRUCTURE ID: 00875
DEFECT DESCRIPTION: End of pipe is both buried and submerged.
PRIORITY: High

ADDRESS: 216 Caroline Street (across from)
PROPERTIES: N/A
LOCATION:

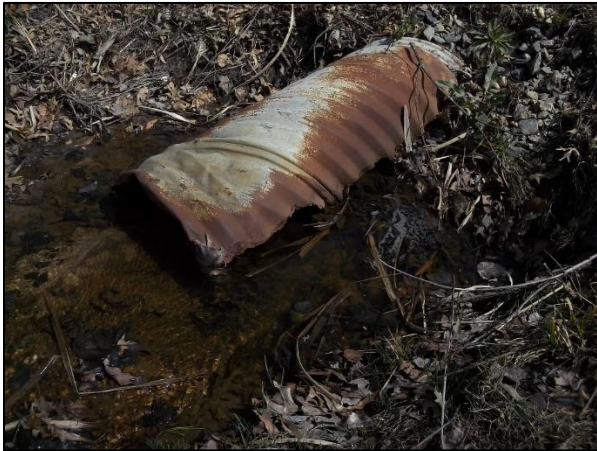
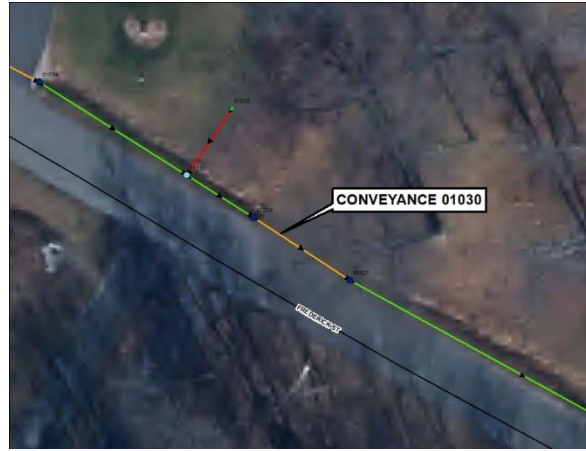
DATE: 03-27-19
CONVEYANCE ID: 01030
DEFECT DESCRIPTION: Bottom of a driveway culvert is corroded and is now missing.
PRIORITY: High

ADDRESS: Frederick Street
PROPERTIES: 15" CMP
LOCATION:

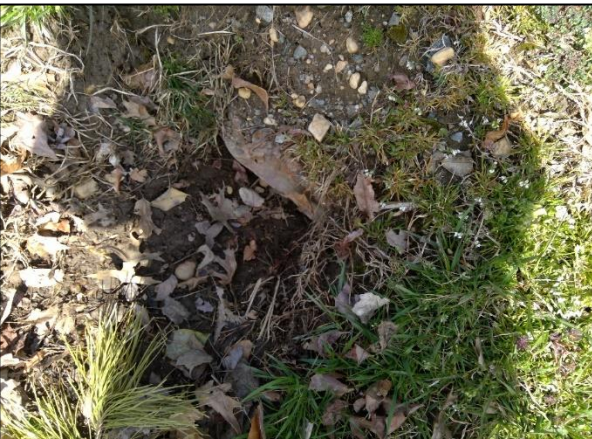
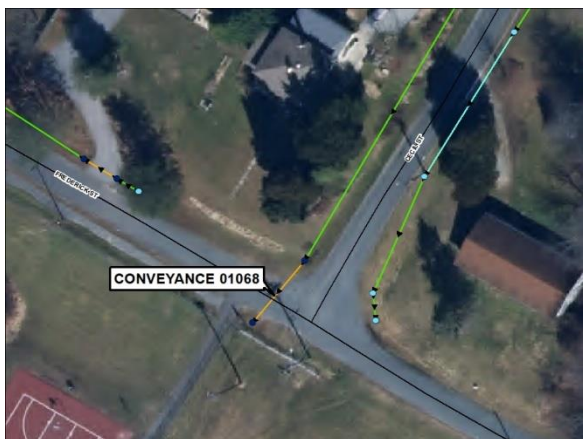
DATE: 03-27-19
CONVEYANCE ID: 01068
DEFECT DESCRIPTION: Pipe is 70% full of debris.
PRIORITY: High

ADDRESS: 607 Cecil Street (side of)
PROPERTIES: 18" CMP
LOCATION:

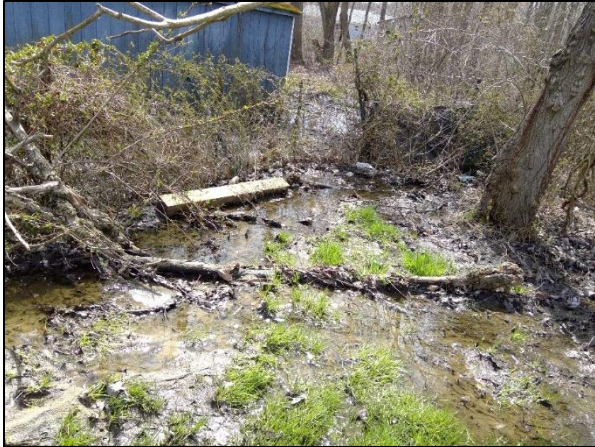
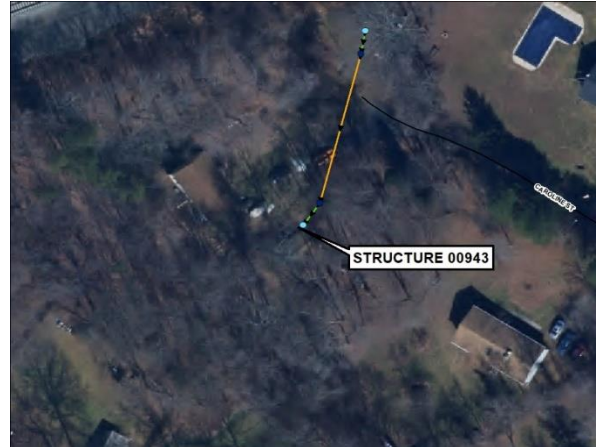
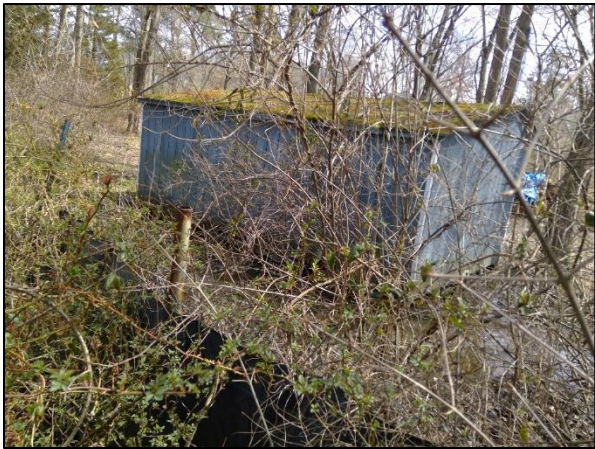
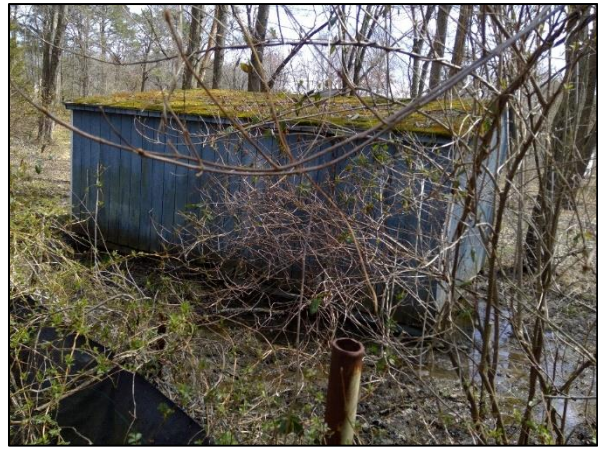
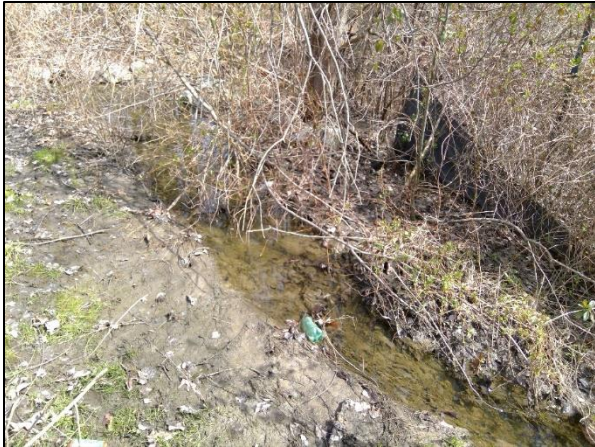
STRUCTURE ID: 00943

DEFECT DESCRIPTION: Drainage leaves right-of-way and floods downstream backyards.

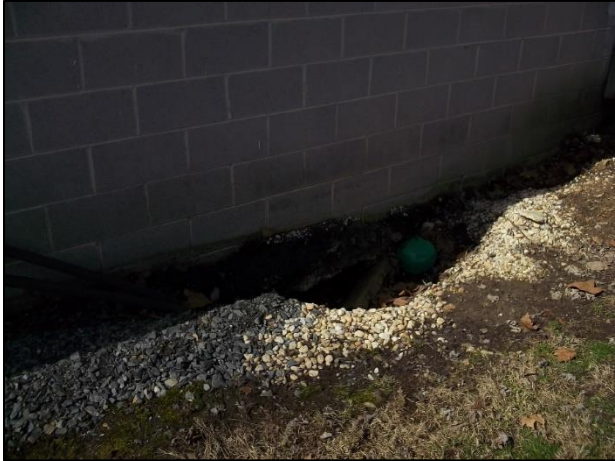
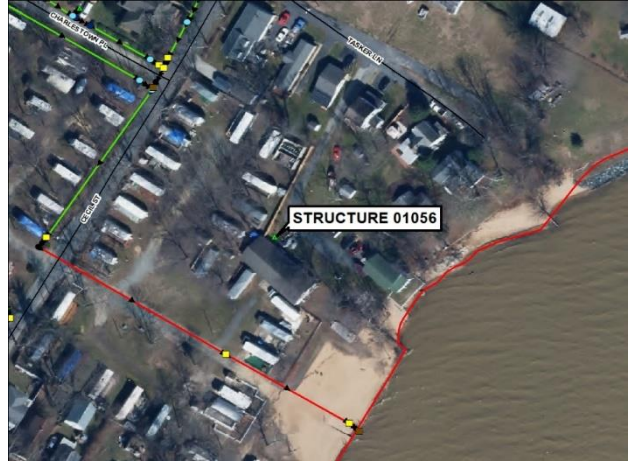
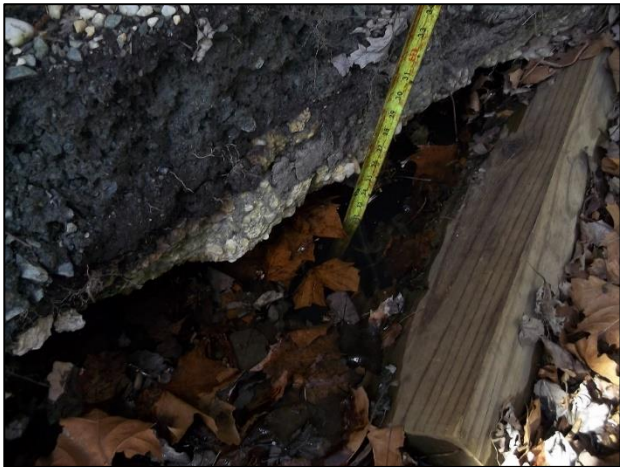
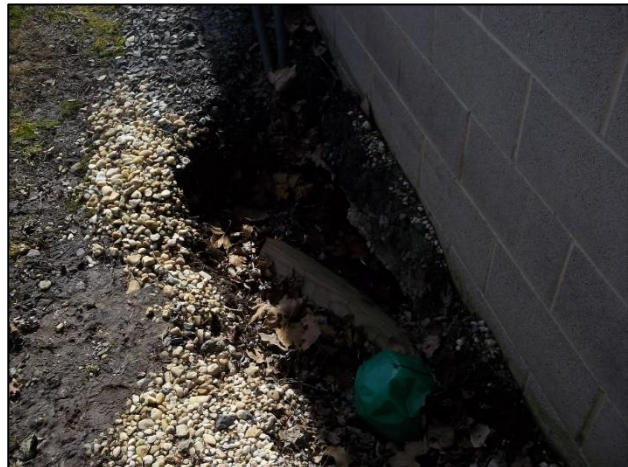
DATE: 03-27-19
STRUCTURE ID: 01056
DEFECT DESCRIPTION: 2 foot sinkhole adjacent to a trailer, filled with water.
PRIORITY: High

ADDRESS: Beach Road
PROPERTIES: N/A
LOCATION:
