Town of Charlestown

Stormwater Vulnerability & Floodplain Management Assessment

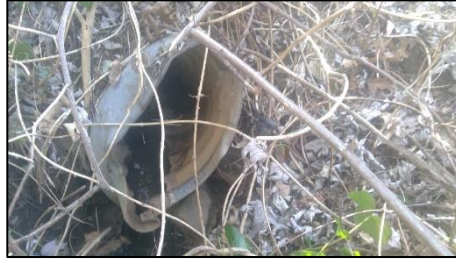
ADDRESS: 231 Louisa Lane
PROPERTIES: 8" CMP
LOCATION:

DEFECT DESCRIPTION:
Bottom of the pipe is corroded and downstream end is misshapen.

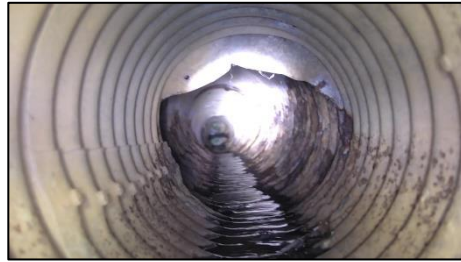
DEFECT DESCRIPTION:
Joint separation in the upstream end of the pipe.

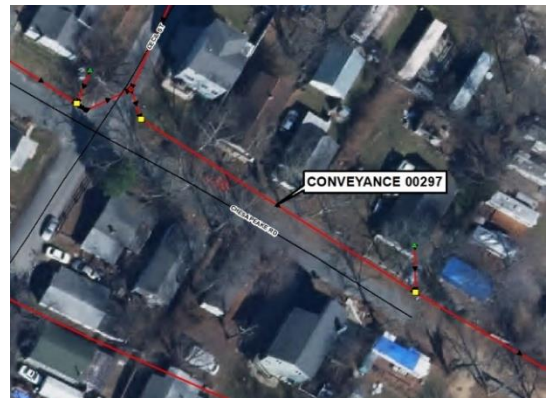
DATE: 01-23-19
CONVEYANCE ID: 00297
DEFECT DESCRIPTION: Joint separation in the bottom of the pipe.
PRIORITY: Low

ADDRESS: Chesapeake Road
PROPERTIES: 17"x13" Arch CMP
LOCATION:

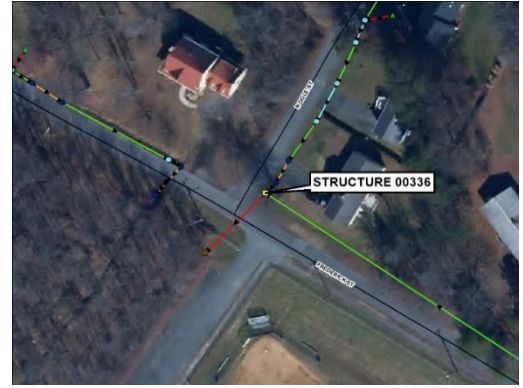
DATE: 01-25-19 **ADDRESS:** Frederick Street (side of 601 N Ogle Street)
STRUCTURE ID: 00336 **PROPERTIES:** N/A
DEFECT DESCRIPTION: Grate does not sit properly in the frame.
PRIORITY: High **LOCATION:**

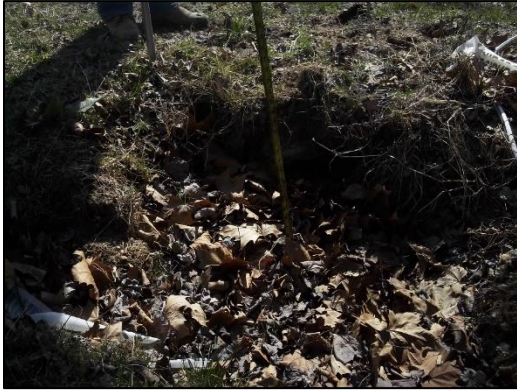
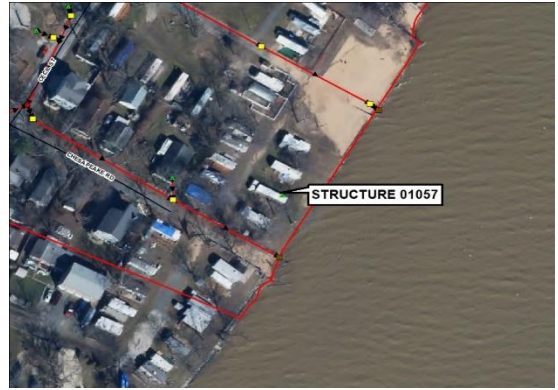
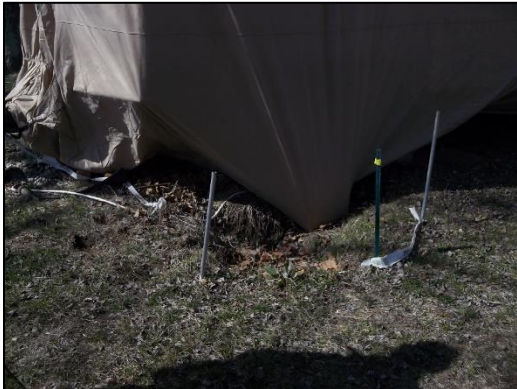
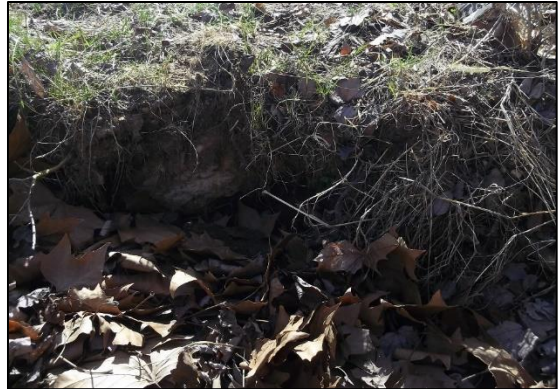
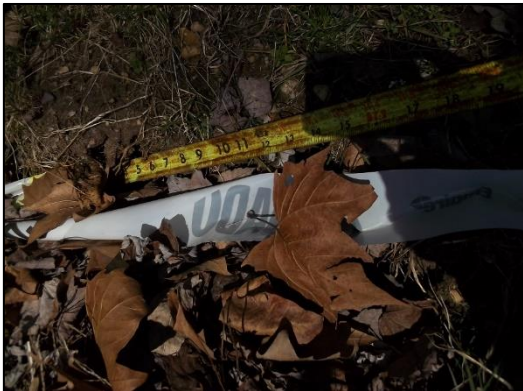
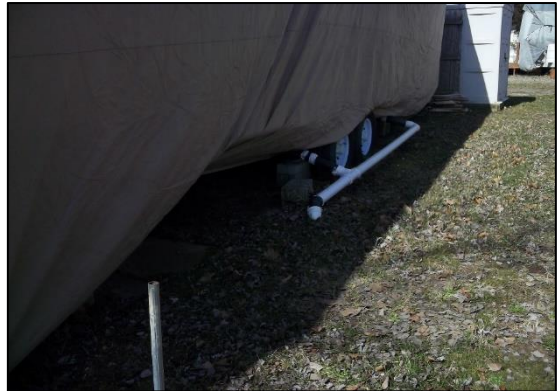
DEFECT DESCRIPTION:

- 1) Sinkhole formed adjacent to a trailer. 12" RCP in the sinkhole, possibly abandoned.

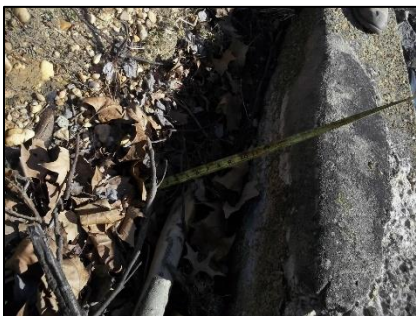
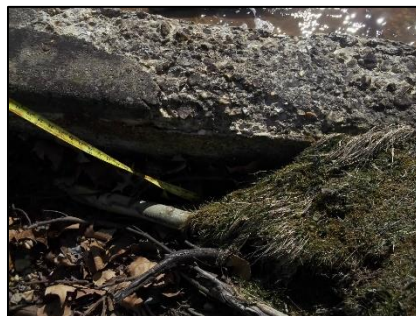
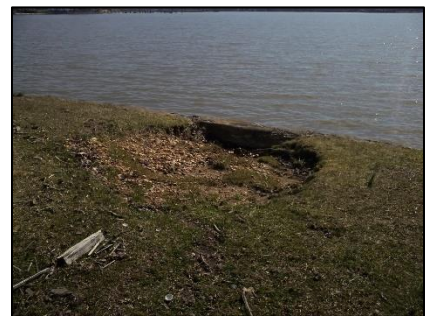
DEFECT DESCRIPTION:

- 2) Second sinkhole a few feet down, on top of the water.

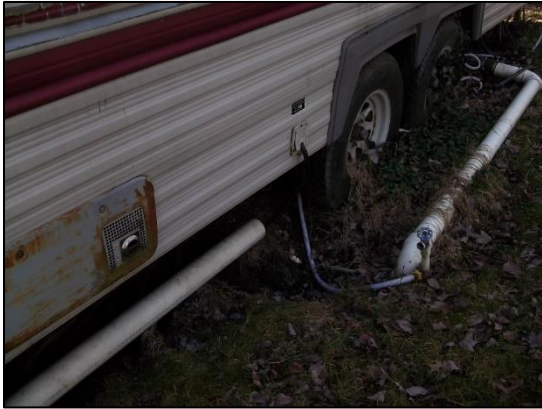
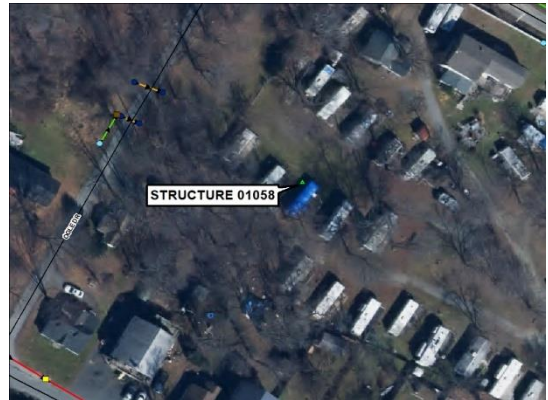
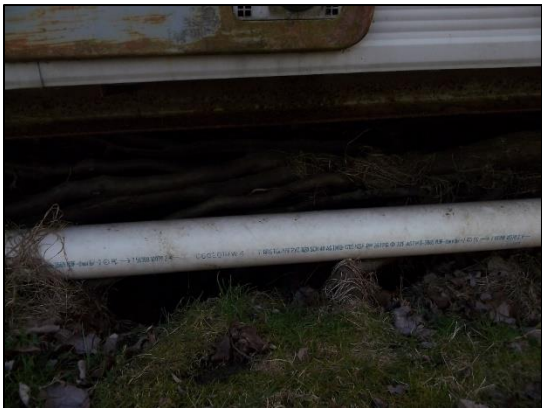
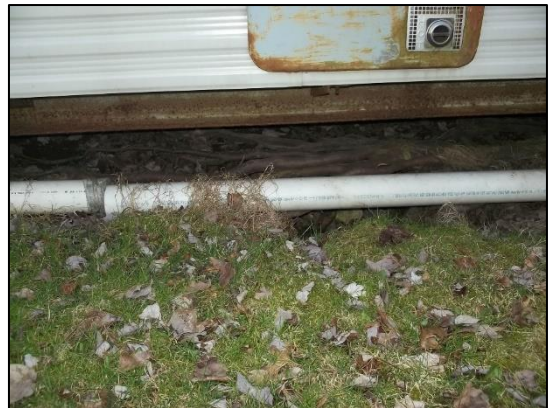
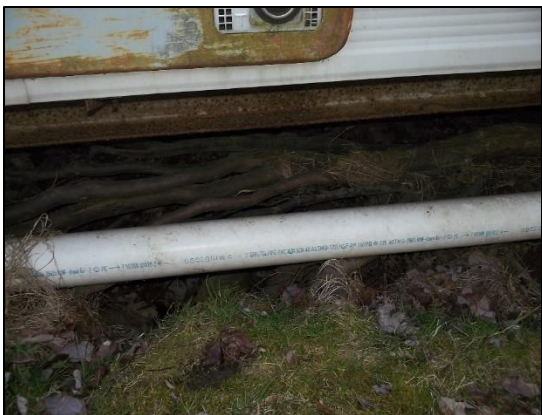
ADDRESS: Beach Road
PROPERTIES: N/A

DATE: 03-27-19
STRUCTURE ID: 01058
DEFECT DESCRIPTION: Sinkhole underneath trailer. Start of runoff heading towards trailer park downstream.
PRIORITY: High
